ST. JAMES LAKE DAM

JEFFERSON COUNTY
NEW YORK

INVENTORY NO NY 779

**PHASE I INSPECTION REPORT
NATIONAL DAM SAFETY PROGRAM**

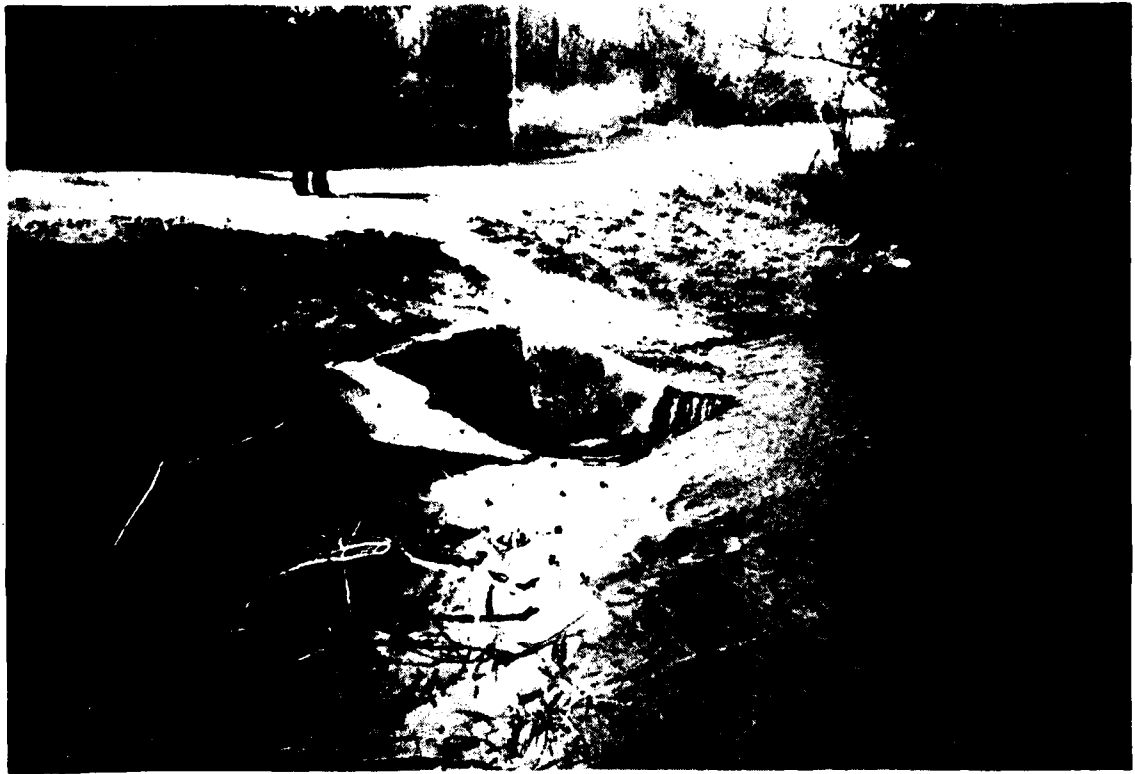
Overview of front of dam showing service spillway.
Dam does not have an emergency spillway or weir type
spillway.

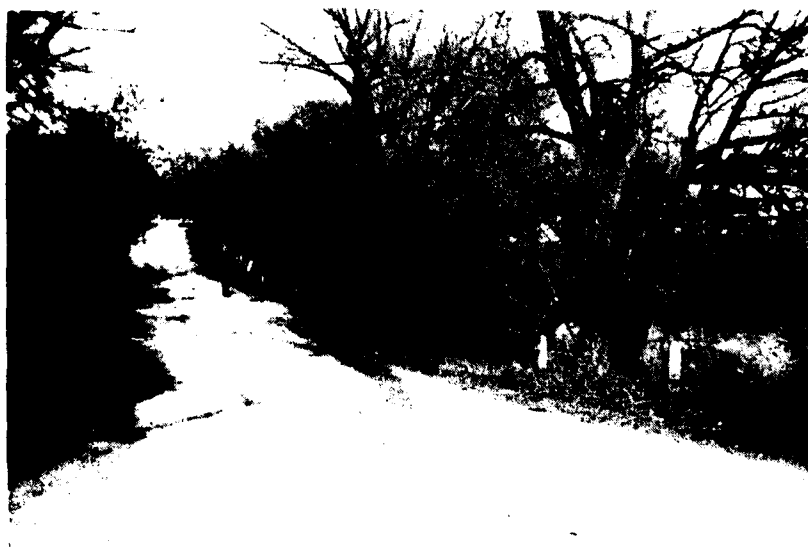
4. View of earthen road across top of dam. Ratio of width of dam to height of dam quite large.

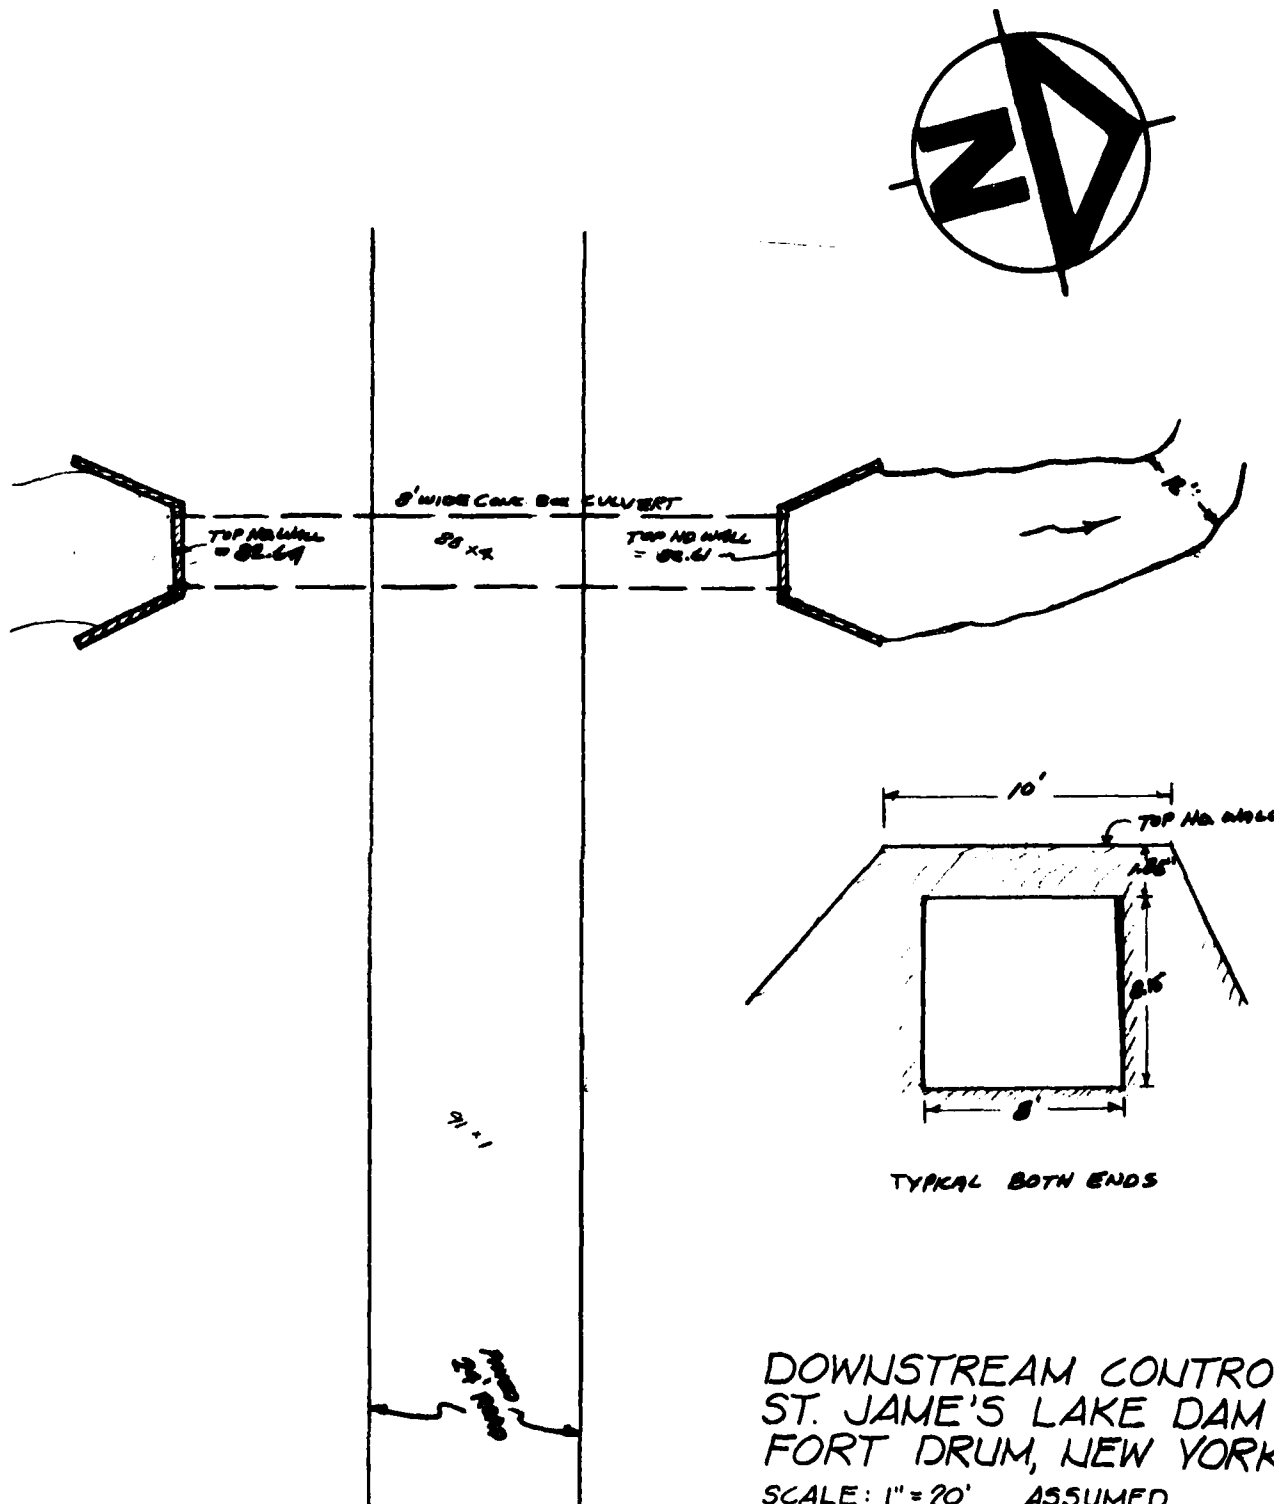
FIGURE 2

The downstream hazard is a lightly traveled road heading north out of the cantonment area. Should dam failure occur, this road would be overtopped to approximately the same depth of the dam overtopping.
